Manhole Inspection Summary

Manhole # S39S__037MH

Insp Date: **3/12/08 2:13 PM**

Location Address: **1403 jackson st**

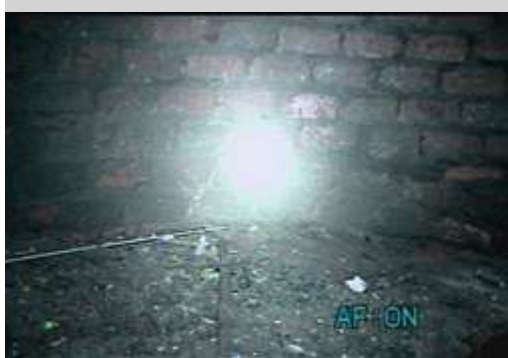
Misc

bench debris

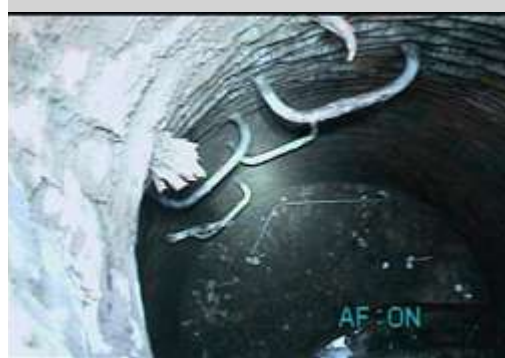
Defect 2

Steps Count: **5** Missing: **1** ☒ **Corroded**

missing/corroded steps

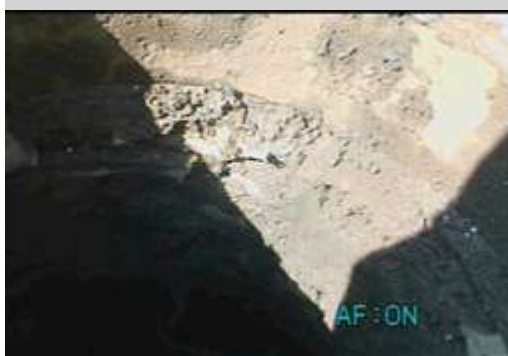
Defect 1

Condition: ☐ Sound ☐ Cracked ☐ Root Intrusion ☐ Loose Brick ☒ **Deteriorated**

Infiltration: ☐ None ☒ **Joint** ☐ Cracks ☐ Mortar ☐ Roots ☐ Wall

Frame Offset, Deteriorated and Leaking Corbel

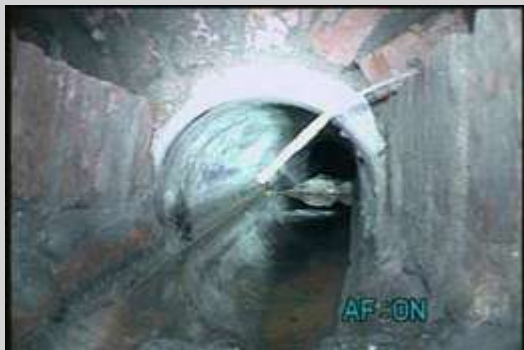
12 O'Clock Outflow

8 in. Circular Gravity Sewer
Pipe Out @ 12 O'Clock

Deposits: ☐ None ☐ Mud ☐ Sludge ☒ **Debris** ☐ Grease

Silt Depth: 2 (in.) Deposits Extent: **Light**

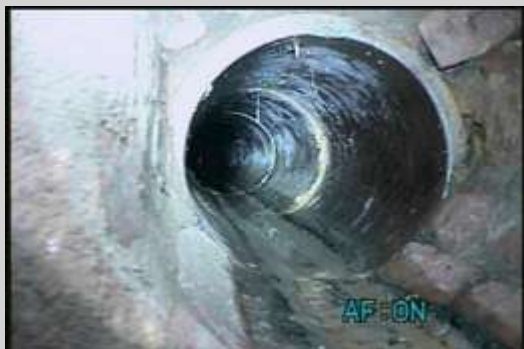
3 O'Clock Inflow

8 in. Circular Gravity Sewer
Pipe In @ 3 O'Clock
